TECHNICAL REPORT GL-85-11

DUSTPROOFING UNSURFACED AREAS; FACILITIES TECHNOLOGY APPLICATION TEST DEMONSTRATIONS, FY 84

Geotechnical Laboratory

September 1985

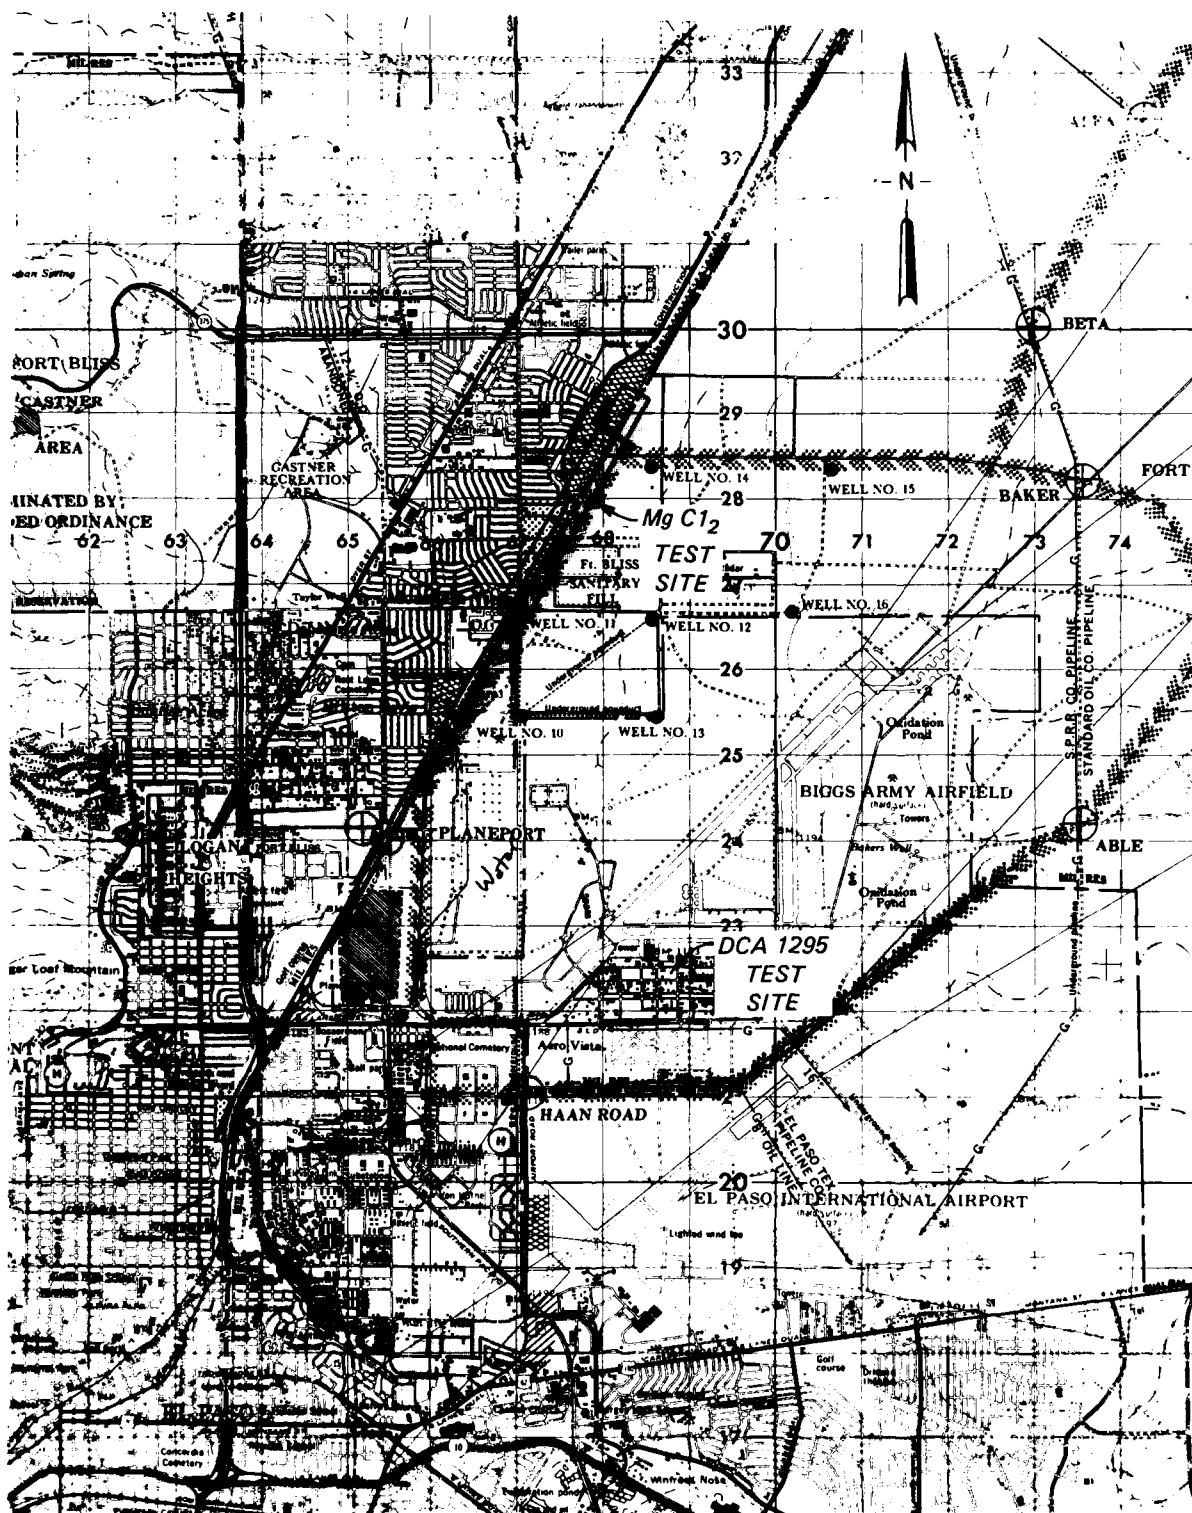
Figure 3. Fort Bliss, Tex., demonstration sites

25. Eighteen drums of PVA were diluted (three parts PVA to one part water) and applied to a nontraffic area measuring 110 by 180 ft. This area is adjacent to Bldg. 11246 located on Sixth Street at Biggs Army Airfield at Fort Bliss (Figure 3). The test area is essentially horizontal with little or no grade. The surface material is brown gravelly silty sand (classified as SP-SM according to the Unified Soil Classification System (USCS)) that dusts readily (Figure 4).

29. Nine thousand gallons of $MgCl_2$ were placed on a tank trail adjacent to the Southern Pacific Railroad Line in the immediate vicinity of the Fort Bliss Sanitary Fill (Figure 3). Actually all types of wheel vehicles, both military and civilian, use this road in addition to the military tracked vehicles. The treated area was limited to 24 ft wide by 6,750 ft long. The entire road width, approximately 50 ft, was not treated in order to provide a dust free corridor for the tracked vehicles that extended the entire length of the adjacent commercial activities in this area. The road material was classified by the USCS as a brown gravelly clayey sand (SM-SC) (Figure 8). The test area is essentially horizontal with little or no grade.

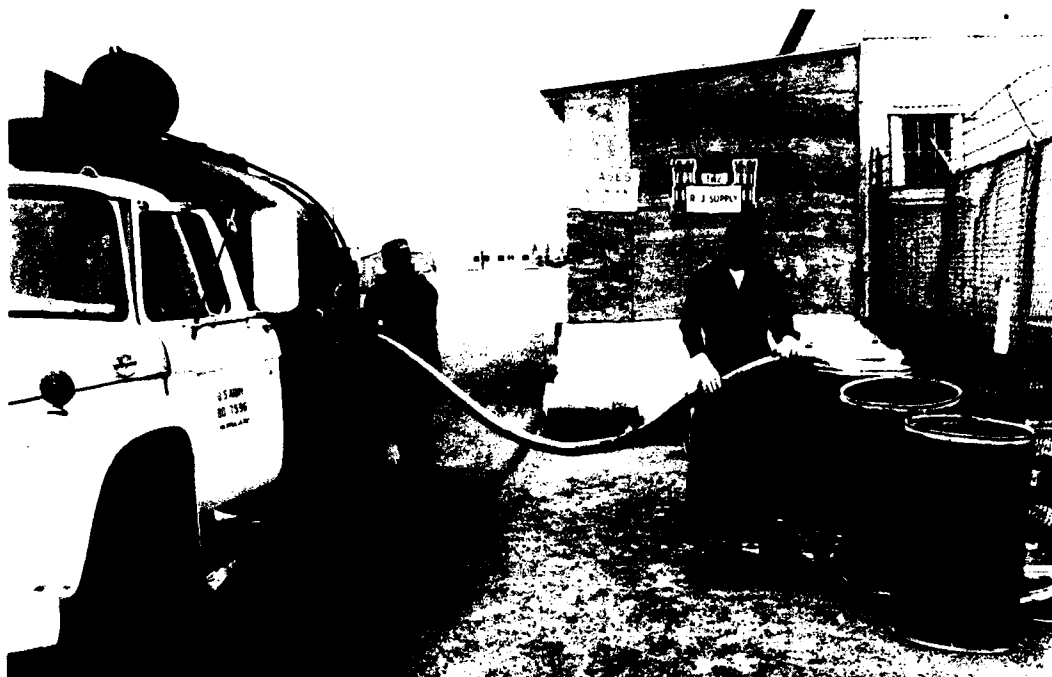
Figure 5. Loading PVA at Fort Bliss, Tex.

26. The WES 900-gal capacity modified asphalt distributor is capable of self-loading from drums (Figure 5). Thus, nine drums of PVA and three drums of water were loaded and mixed, and approximately one-half the area was treated. A 12-ft-wide spray bar was used to apply a strip the same width with each pass (Figure 6). The desired application rate was set by the distributor driver/operator as follows:

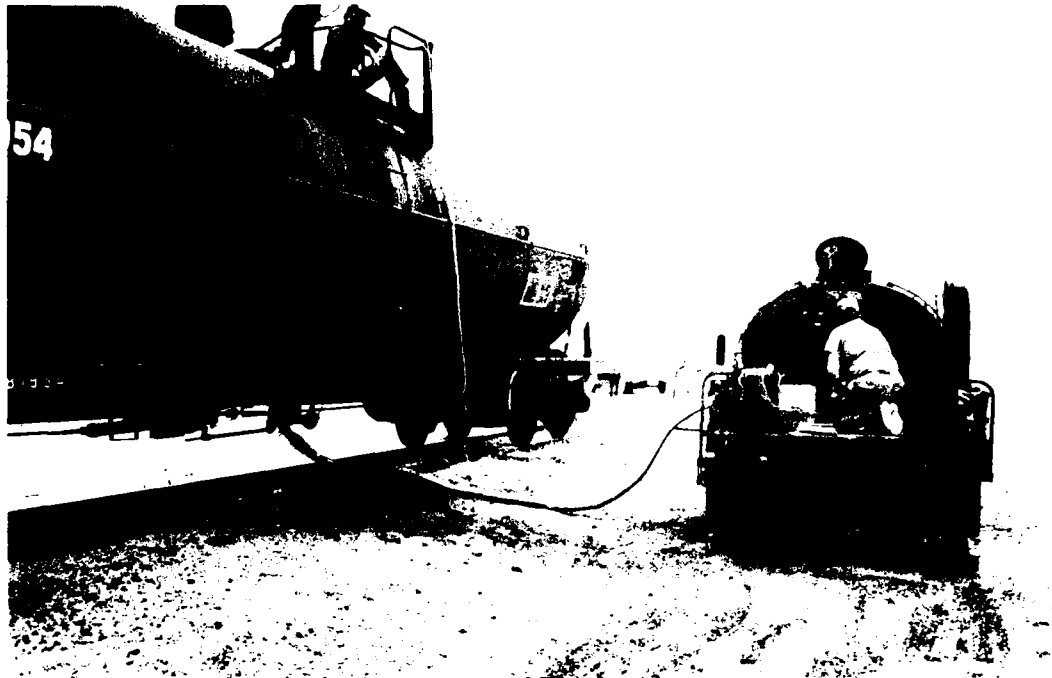
Figure 9. Loading product MgCl_2 from railroad tank car

30. The WES 900-gal capacity modified asphalt distributor was loaded directly from the railroad tank car used to ship the $MgCl_2$ (Figure 9). A special collar device was required to attach the distributor supply hose to the railroad tank car (Figure 10). The collar must fit a threaded pipe approximately 4-1/4 in. in diameter, turn 45 deg (preferably 90 deg), and the opposite end fit the 3-1/2-in. supply hose.

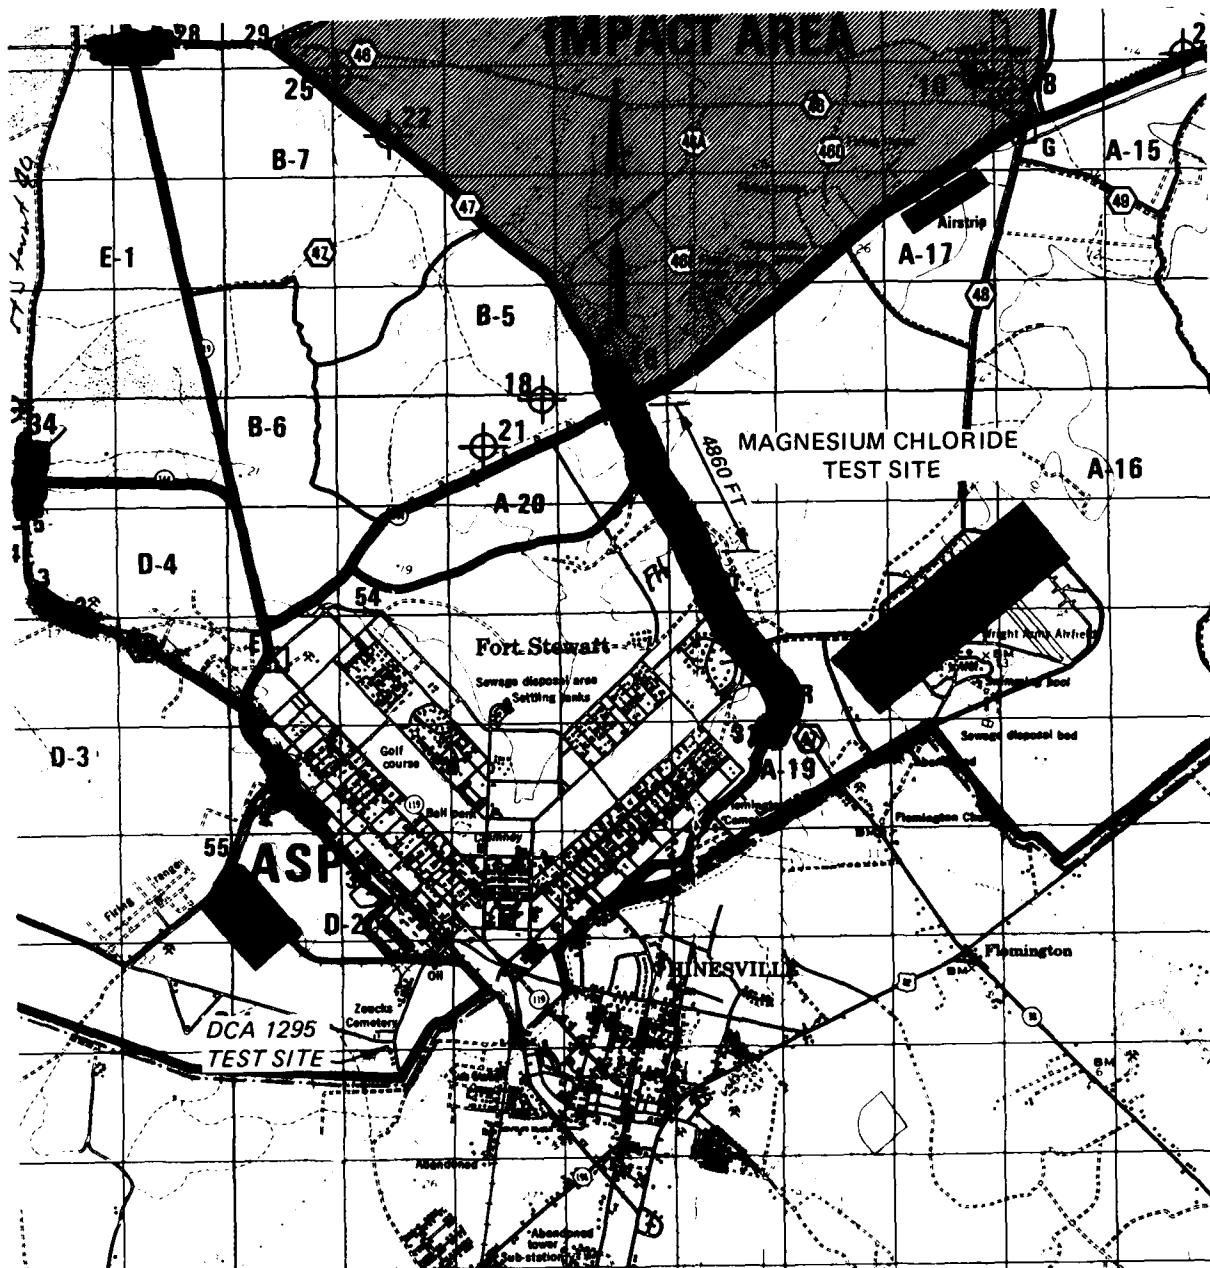
Figure 12. Fort Stewart military installation

33. The PVA test site is in an area that is used to load and unload a warehouse located near Zoucks Cemetery (Figures 12 and 13a). Eighteen drums of PVA were diluted three parts PVA to one part water and applied to an area 200 by 90 ft for an actual application rate of 0.49 gal/sq yd (Figure 13b).

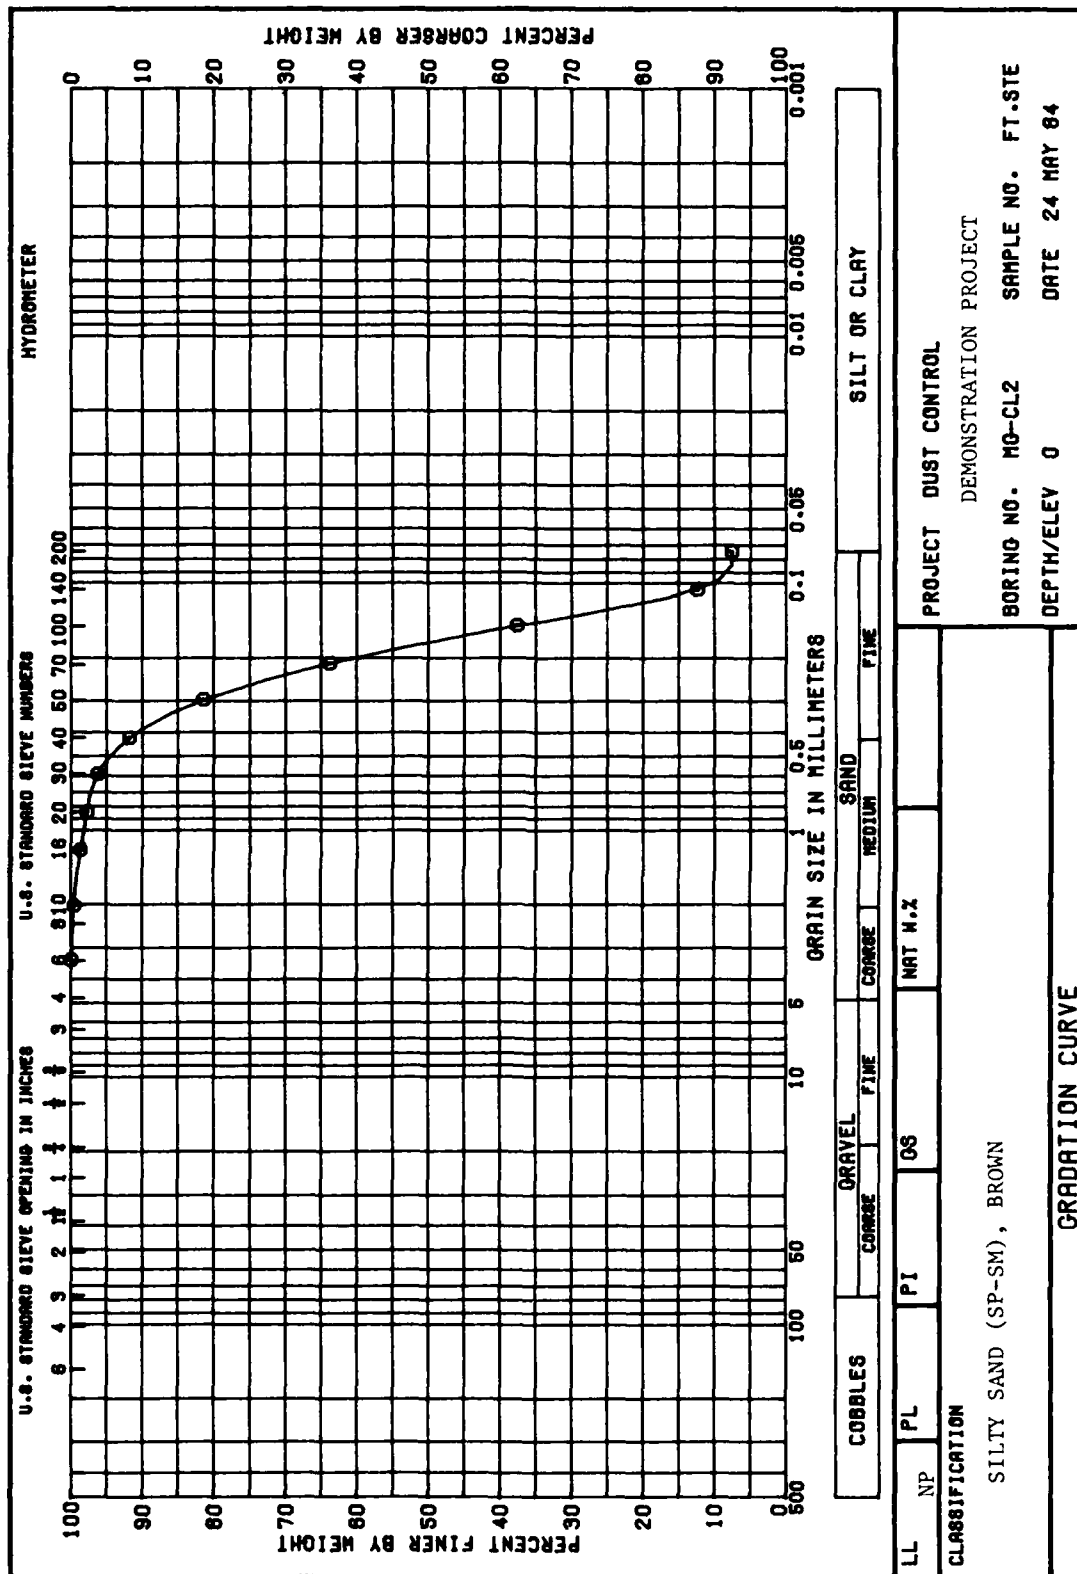
Figure 15. MgCl₂ site soil classification, Fort Stewart, Ga.

35. The $MgCl_2$ test area is an unsurfaced road (Fort Stewart 47) used primarily by tracked and other military vehicles. This road parallels Georgia 47 approximately 200 yd to the northeast. The test section begins at the intersection of Georgia State Highway 144 and Fort Stewart 47 and proceeds 4,860 ft southeasterly (Figure 12). The roadbed width varies but is approximately 30 ft wide. The roadbed surface was classified by the USCS as a brown silty sand (SP-SM) (Figure 15).
